Manhole Inspection Summary

Manhole # S31GG2003MH

Insp Date: **12/20/06 2:02 PM**

Location Address: **5718 CHARLESTOWNE DR**

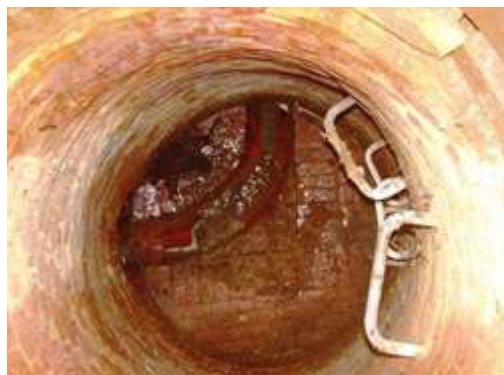
Top View

Bench and Channel debris.

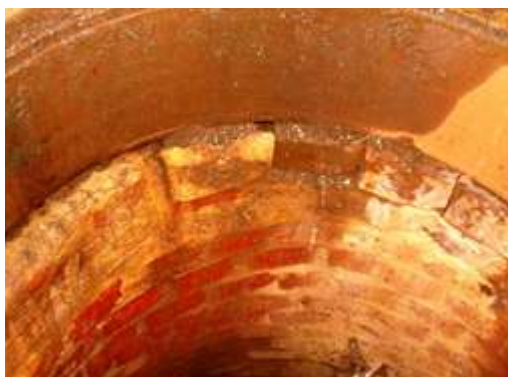
Defect

Frame leaks. Adjustment deterioration, loose brick, and infiltration.

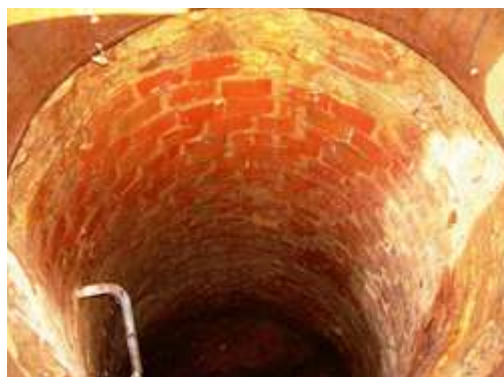
Defect

Frame leaks. Adjustment deterioration and infiltration. Corbel and Barrel infiltration. - other side.

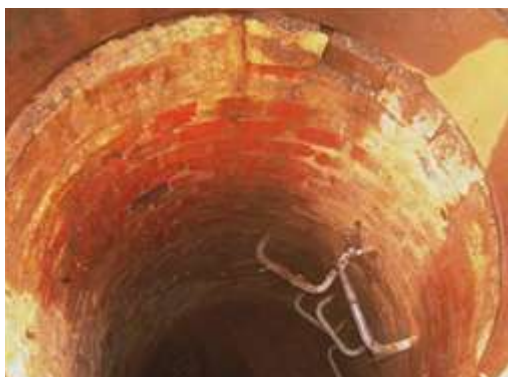
Defect

Frame leaks. Frame offset. Adjustment deterioration, loose brick, and infiltration. Corbel and Barrel infiltration.

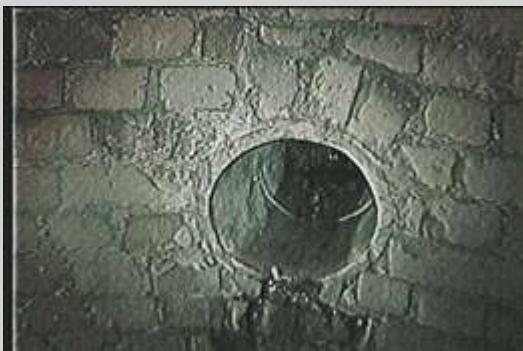
8 in. Circular Gravity Sewer Pipe In @ 9 O'Clock

Barrel deterioration and infiltration.

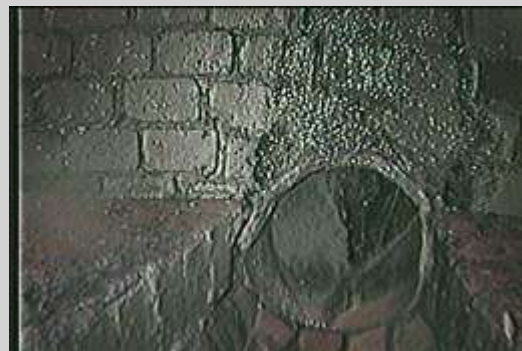
Drop In @ 9 O'Clock

Drop Condition: **Partly Clogged**
